# Earthquake Walk at Central Park

## *The Earthquake Patio*

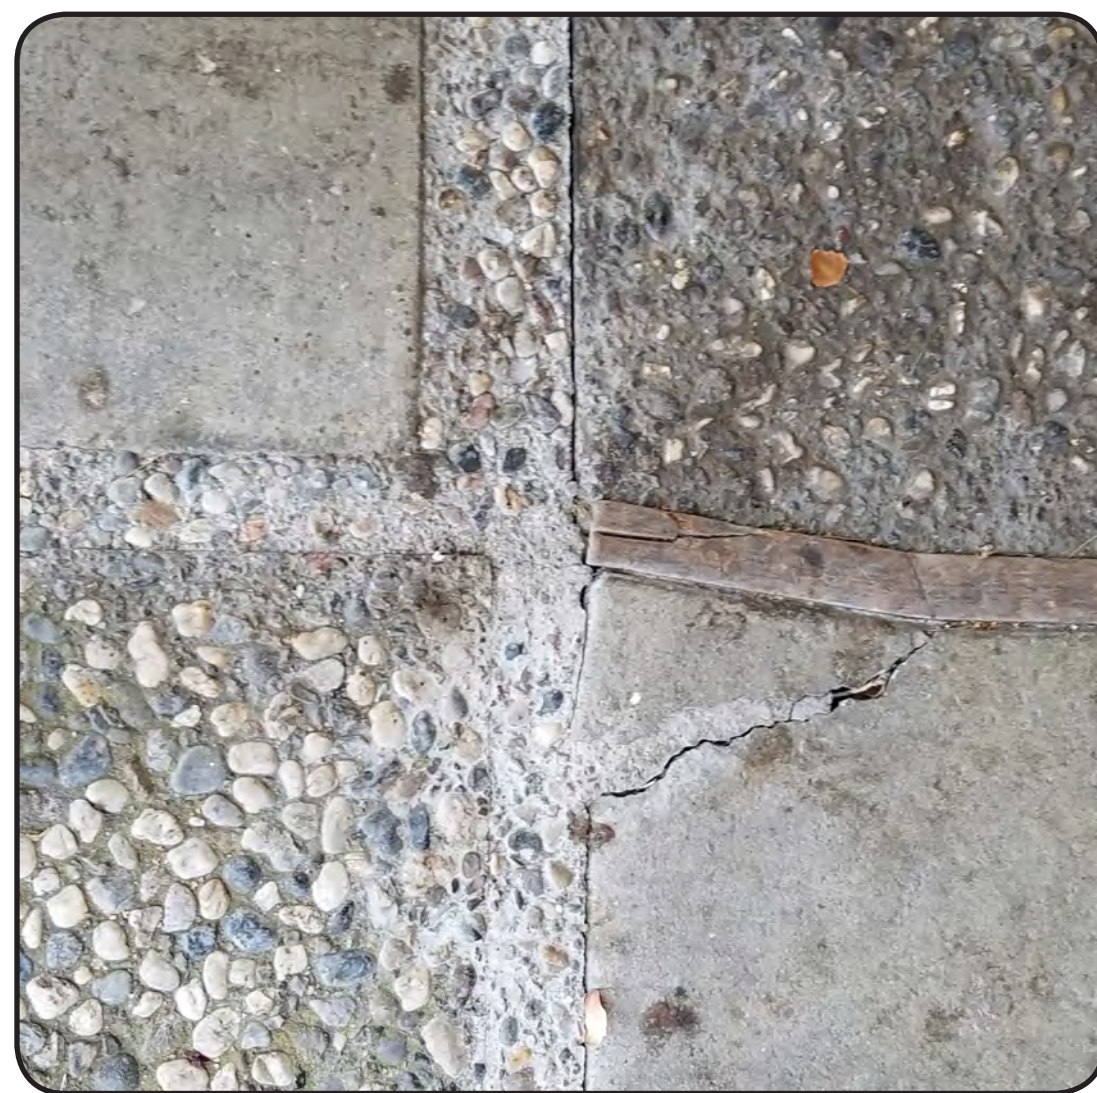
The side of the building facing Lake Elizabeth shows several examples of tectonic movement caused by a strike-slip motion along the Hayward Fault. A strike-slip fault is when one land mass moves, nearly horizontally, in the opposite direction of the other on the surface. The movement on the patio reflects larger land structures that are forming throughout Central Park. Lake Elizabeth and Stivers Lagoon (south of lake) are larger depressions, while the hilly areas (north) reflect a compression. Strike-slip faults show transpressional compression (knolls) and transtensional extension (depressions).

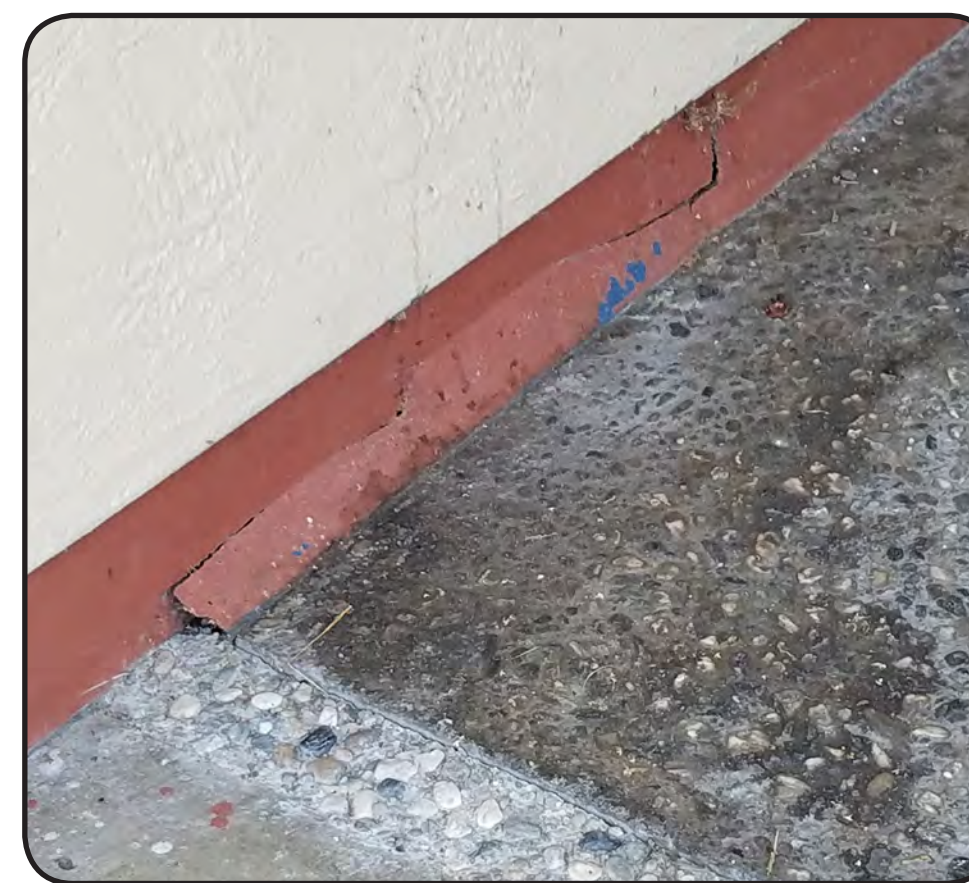
Wood and concrete react differently to constant fault creep. Look at the wood strips between the concrete and notice the wood is bending. As the wood bends, the concrete will crack.
